INDOOR AIR QUALITY ASSESSMENT

**Lincoln Elementary School
161 Mystic Valley Parkway
Winchester, Massachusetts**

Prepared by:
Massachusetts Department of Public Health
Bureau of Environmental Health Assessment
Emergency Response/Indoor Air Quality Program
November 2003

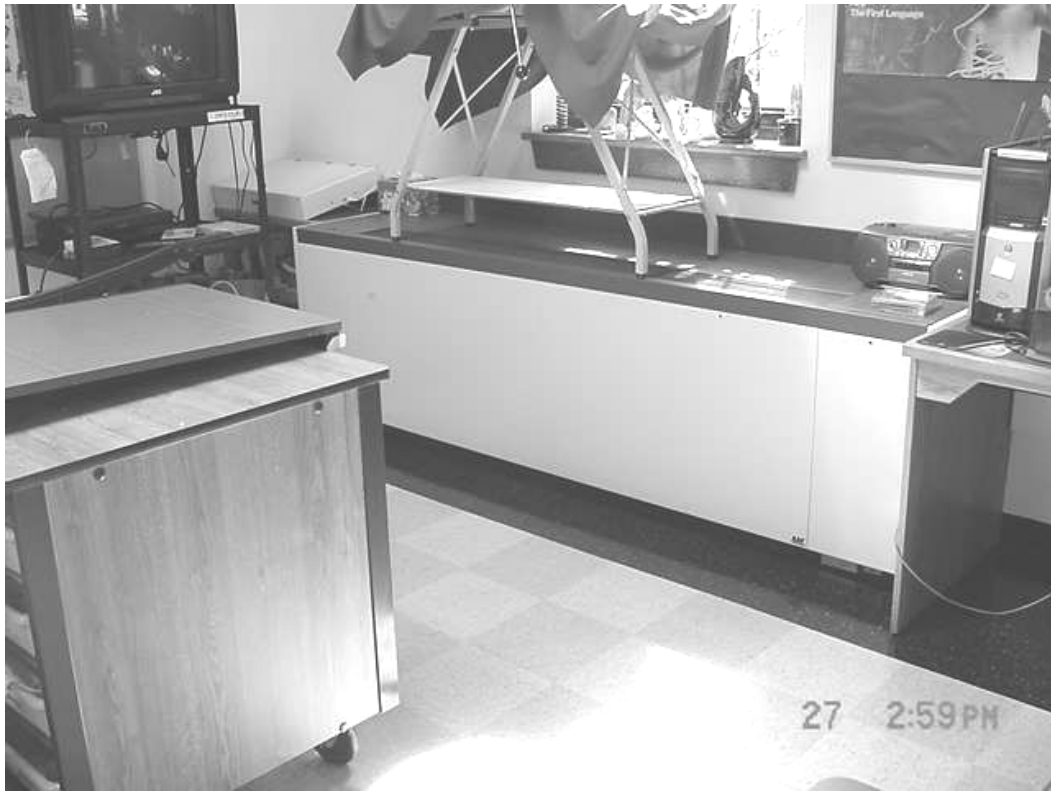
Picture 1

It can be seen from Table 1 that carbon dioxide levels were below 800 parts per million parts of air (ppm) in 16 of 19 areas surveyed, indicating adequate ventilation in most areas of the school. Fresh air in classrooms is supplied by a unit ventilator (univent) system (Picture 1). Classroom temperature and airflow from univents is controlled by a centralized computer system. Univents draw air from outdoors through fresh air intakes located on the exterior walls of the building (Picture 2) and return air through air intakes located at the base of each unit ([Figure 1](#)). Fresh air and return air are mixed, filtered, heated and distributed to classrooms through a fresh air diffuser located in the top of the unit. Some univents were found deactivated or obstructed (Table 1), preventing airflow.

Classroom Univent

In order for univents to provide fresh air as designed, they must be allowed to operate and remain free of obstructions.

5. Remove all blockages from univents to ensure adequate airflow.
6. For buildings in New England, periods of low relative humidity during the winter are often unavoidable. Therefore, scrupulous cleaning practices should be adopted to minimize common indoor air contaminants whose irritant effects can be enhanced when the relative humidity is low. To control for dusts, a high efficiency particulate arrestance (HEPA) filter equipped vacuum cleaner in conjunction with wet wiping of all surfaces is recommended. Drinking water during the day can help ease some symptoms associated with a dry environment (e.g. throat and sinus irritations).

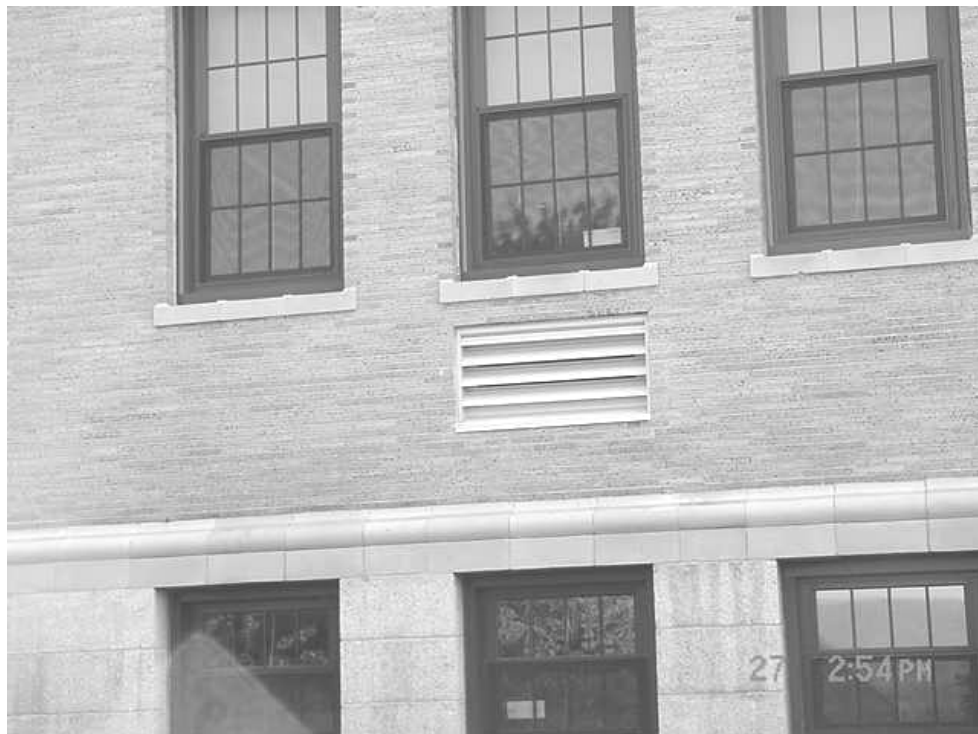
Picture 2

Univent Fresh Air Intake

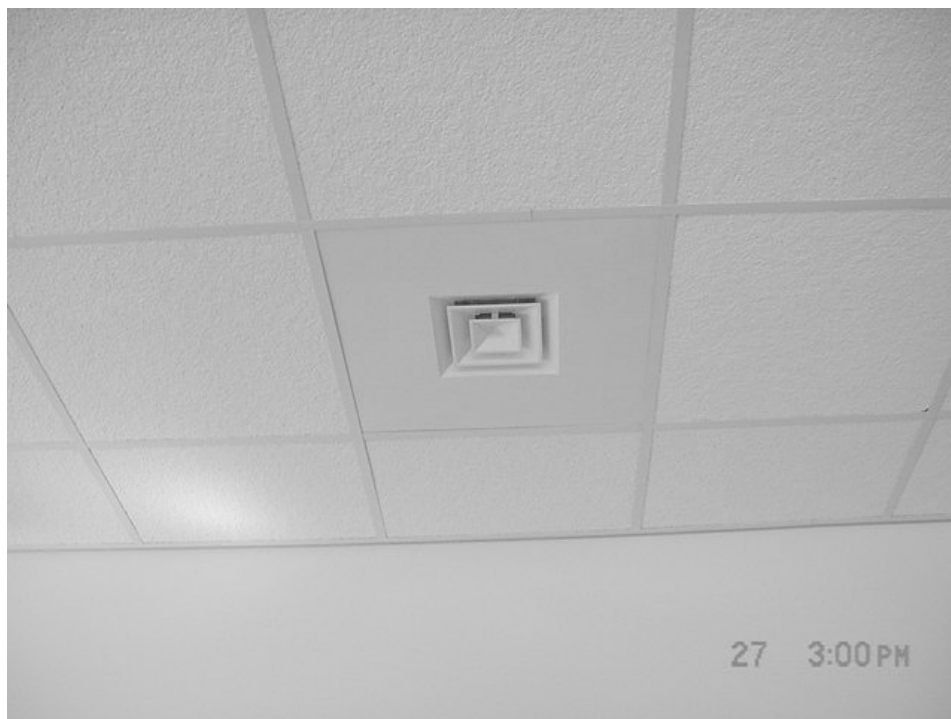
Picture 3

The mechanical exhaust ventilation system in classrooms is provided by wall or ceiling-mounted exhaust vents (Picture 3). Exhaust air is expelled from the building by motorized exhaust vents located on the roof. These vents were operating throughout the building.

Classroom Exhaust Vent

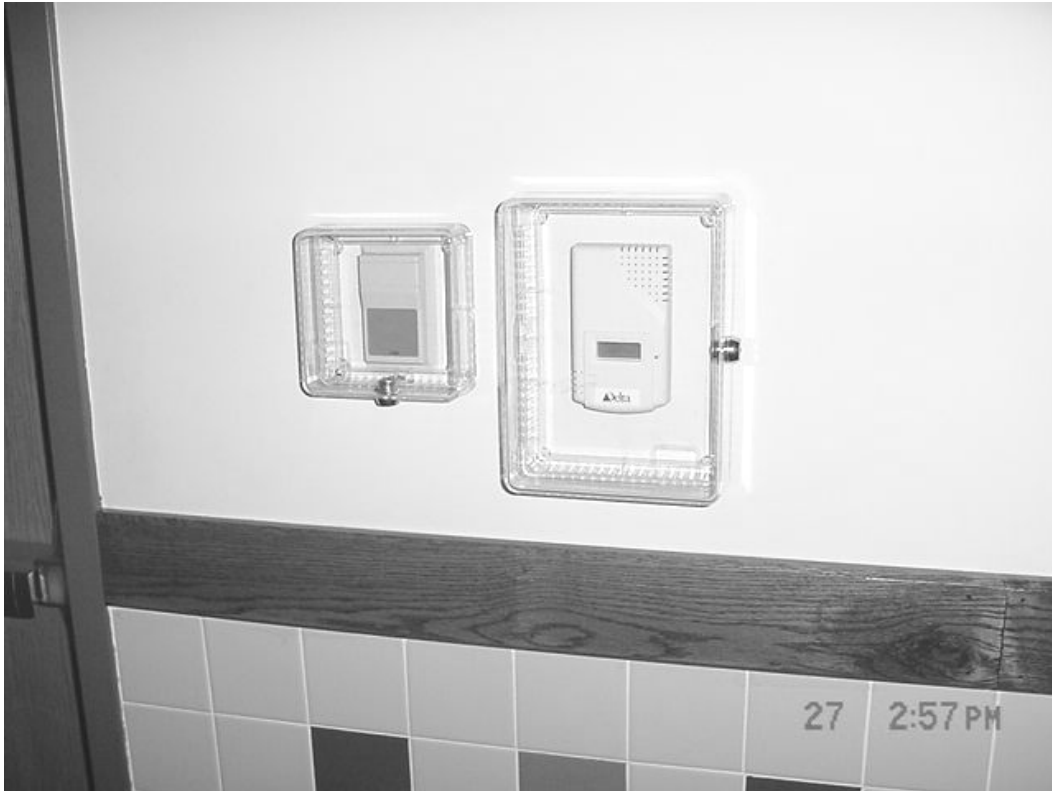
Picture 4

Mechanical ventilation in common areas such as the cafeteria, gymnasium and auditorium are provided by air handling units (AHUs). As with the univent system, AHUs are controlled from a central computer terminal. The activation of the cafeteria ventilation system appears to be dependent on a carbon dioxide sensor (Picture 4). Once a pre-set reading is exceeded, the AHU is activated to introduce fresh air. When a second, *lower* pre-set reading is measured by the sensor, the ventilation system is deactivated. Therefore, no mechanical ventilation is provided until the sensor re-activates the system. The cafeteria ventilation system was not operating during the lunch hour. In addition, the digital readout on the monitor read approximately 700 ppm as compared to the BEHA reading of 1,744 (over 1,000 ppm less than the BEHA measurement). School officials could not identify the date of calibration for this carbon dioxide monitor/HVAC controller.

Carbon Dioxide Monitor With Digital Readout in Cafeteria (on right)

1. Contact the school's HVAC engineer and/or architect regarding the operation and function of the carbon dioxide monitor in the cafeteria. Maintain and calibrate it in accordance with the manufacturer's instructions.
2. Operate both supply and exhaust ventilation continuously during periods of school occupancy.
3. Contact the school's HVAC engineer to investigate and repair temperature controls in classrooms 305 and 317, as well as in other areas with heat complaints.
4. Confirm whether the ventilation systems were balanced as part of the recent renovations. If they have not been balanced, consult a ventilation engineer

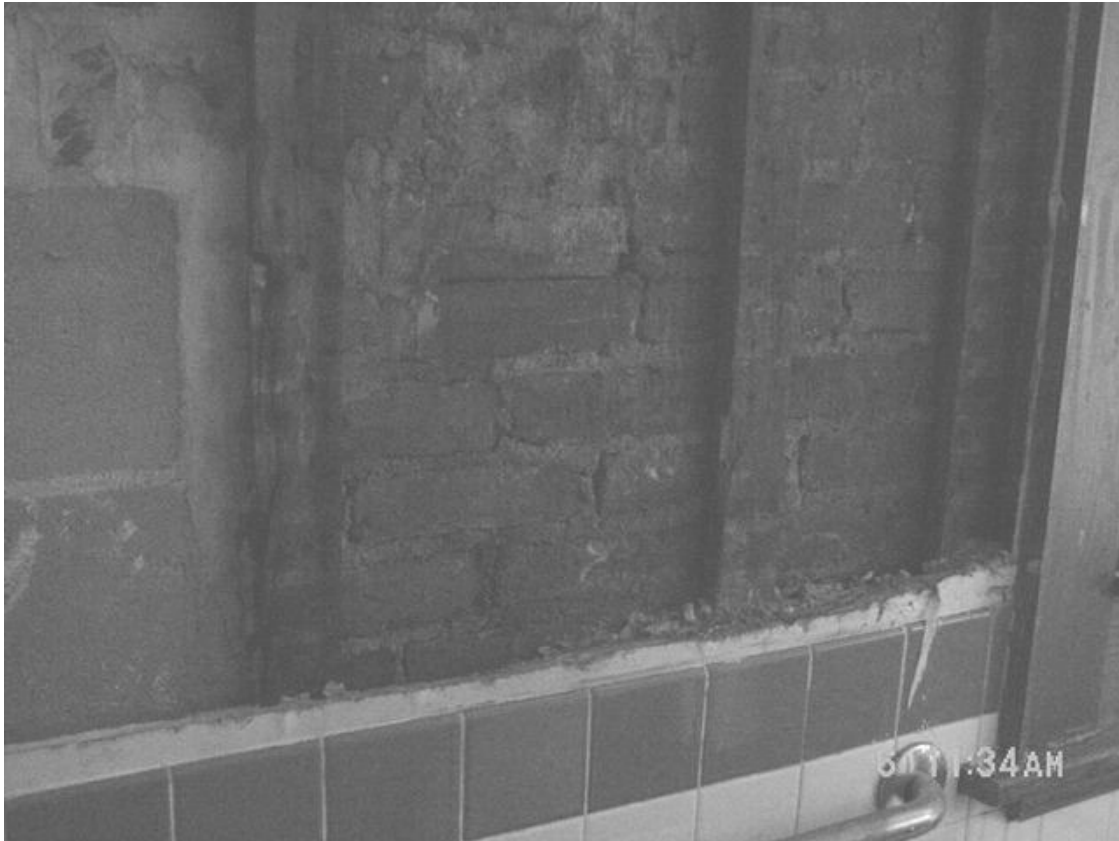
Picture 5

At the time of the May 6, 2003 visit, Mr. Burchill reported that the third floor girl's restroom was experiencing leakage and showed signs of water damage to the ceiling and walls (Picture 5). In order for building materials to support mold growth, a source of water exposure is necessary. Identification and elimination of water moistening

The Delmhorst probe is equipped with three lights as visual aids to determine moisture level. Readings which activate the green light indicate a sufficiently dry moisture level (0 - 0.5%), those that activate the yellow light indicate borderline conditions (0.5 – 1.0%) and those that activate the red light indicate elevated moisture content (> 1%). Elevated moisture measurements were recorded in several areas. GW with elevated moisture readings was noticeably wet and soft to the touch. These results indicated that the building materials were moistened at the time of the assessment.

Water Damaged GW in Third Floor Girls Restroom

The American Conference of Governmental Industrial Hygienists (ACGIH) recommends that porous materials (e.g. GW) be dried with fans and heating within 24 hours of becoming wet (ACGIH, 1989). If porous materials are not dried within this time frame, mold growth may occur. Water-damaged porous materials cannot be adequately cleaned to remove mold growth. The application of a mildewcide to moldy materials is not recommended.

In subsequent correspondence with Mr. Burchill, it was reported that the source of moisture impacting GW was identified as a breach in exterior flashing. The breach was repaired and water damaged GW and ceiling tiles were replaced. BEHA staff confirmed these repairs during the August 8, 2003 visit.
